AQUATIC RESOURCE DELINEATION REPORT
FOR THE
TILDEN PROJECT
COLUMBIA COUNTY, NEW YORK

June 11, 2025

Lamont Engineers
197 Elm Street
Cobleskill, NY 12043

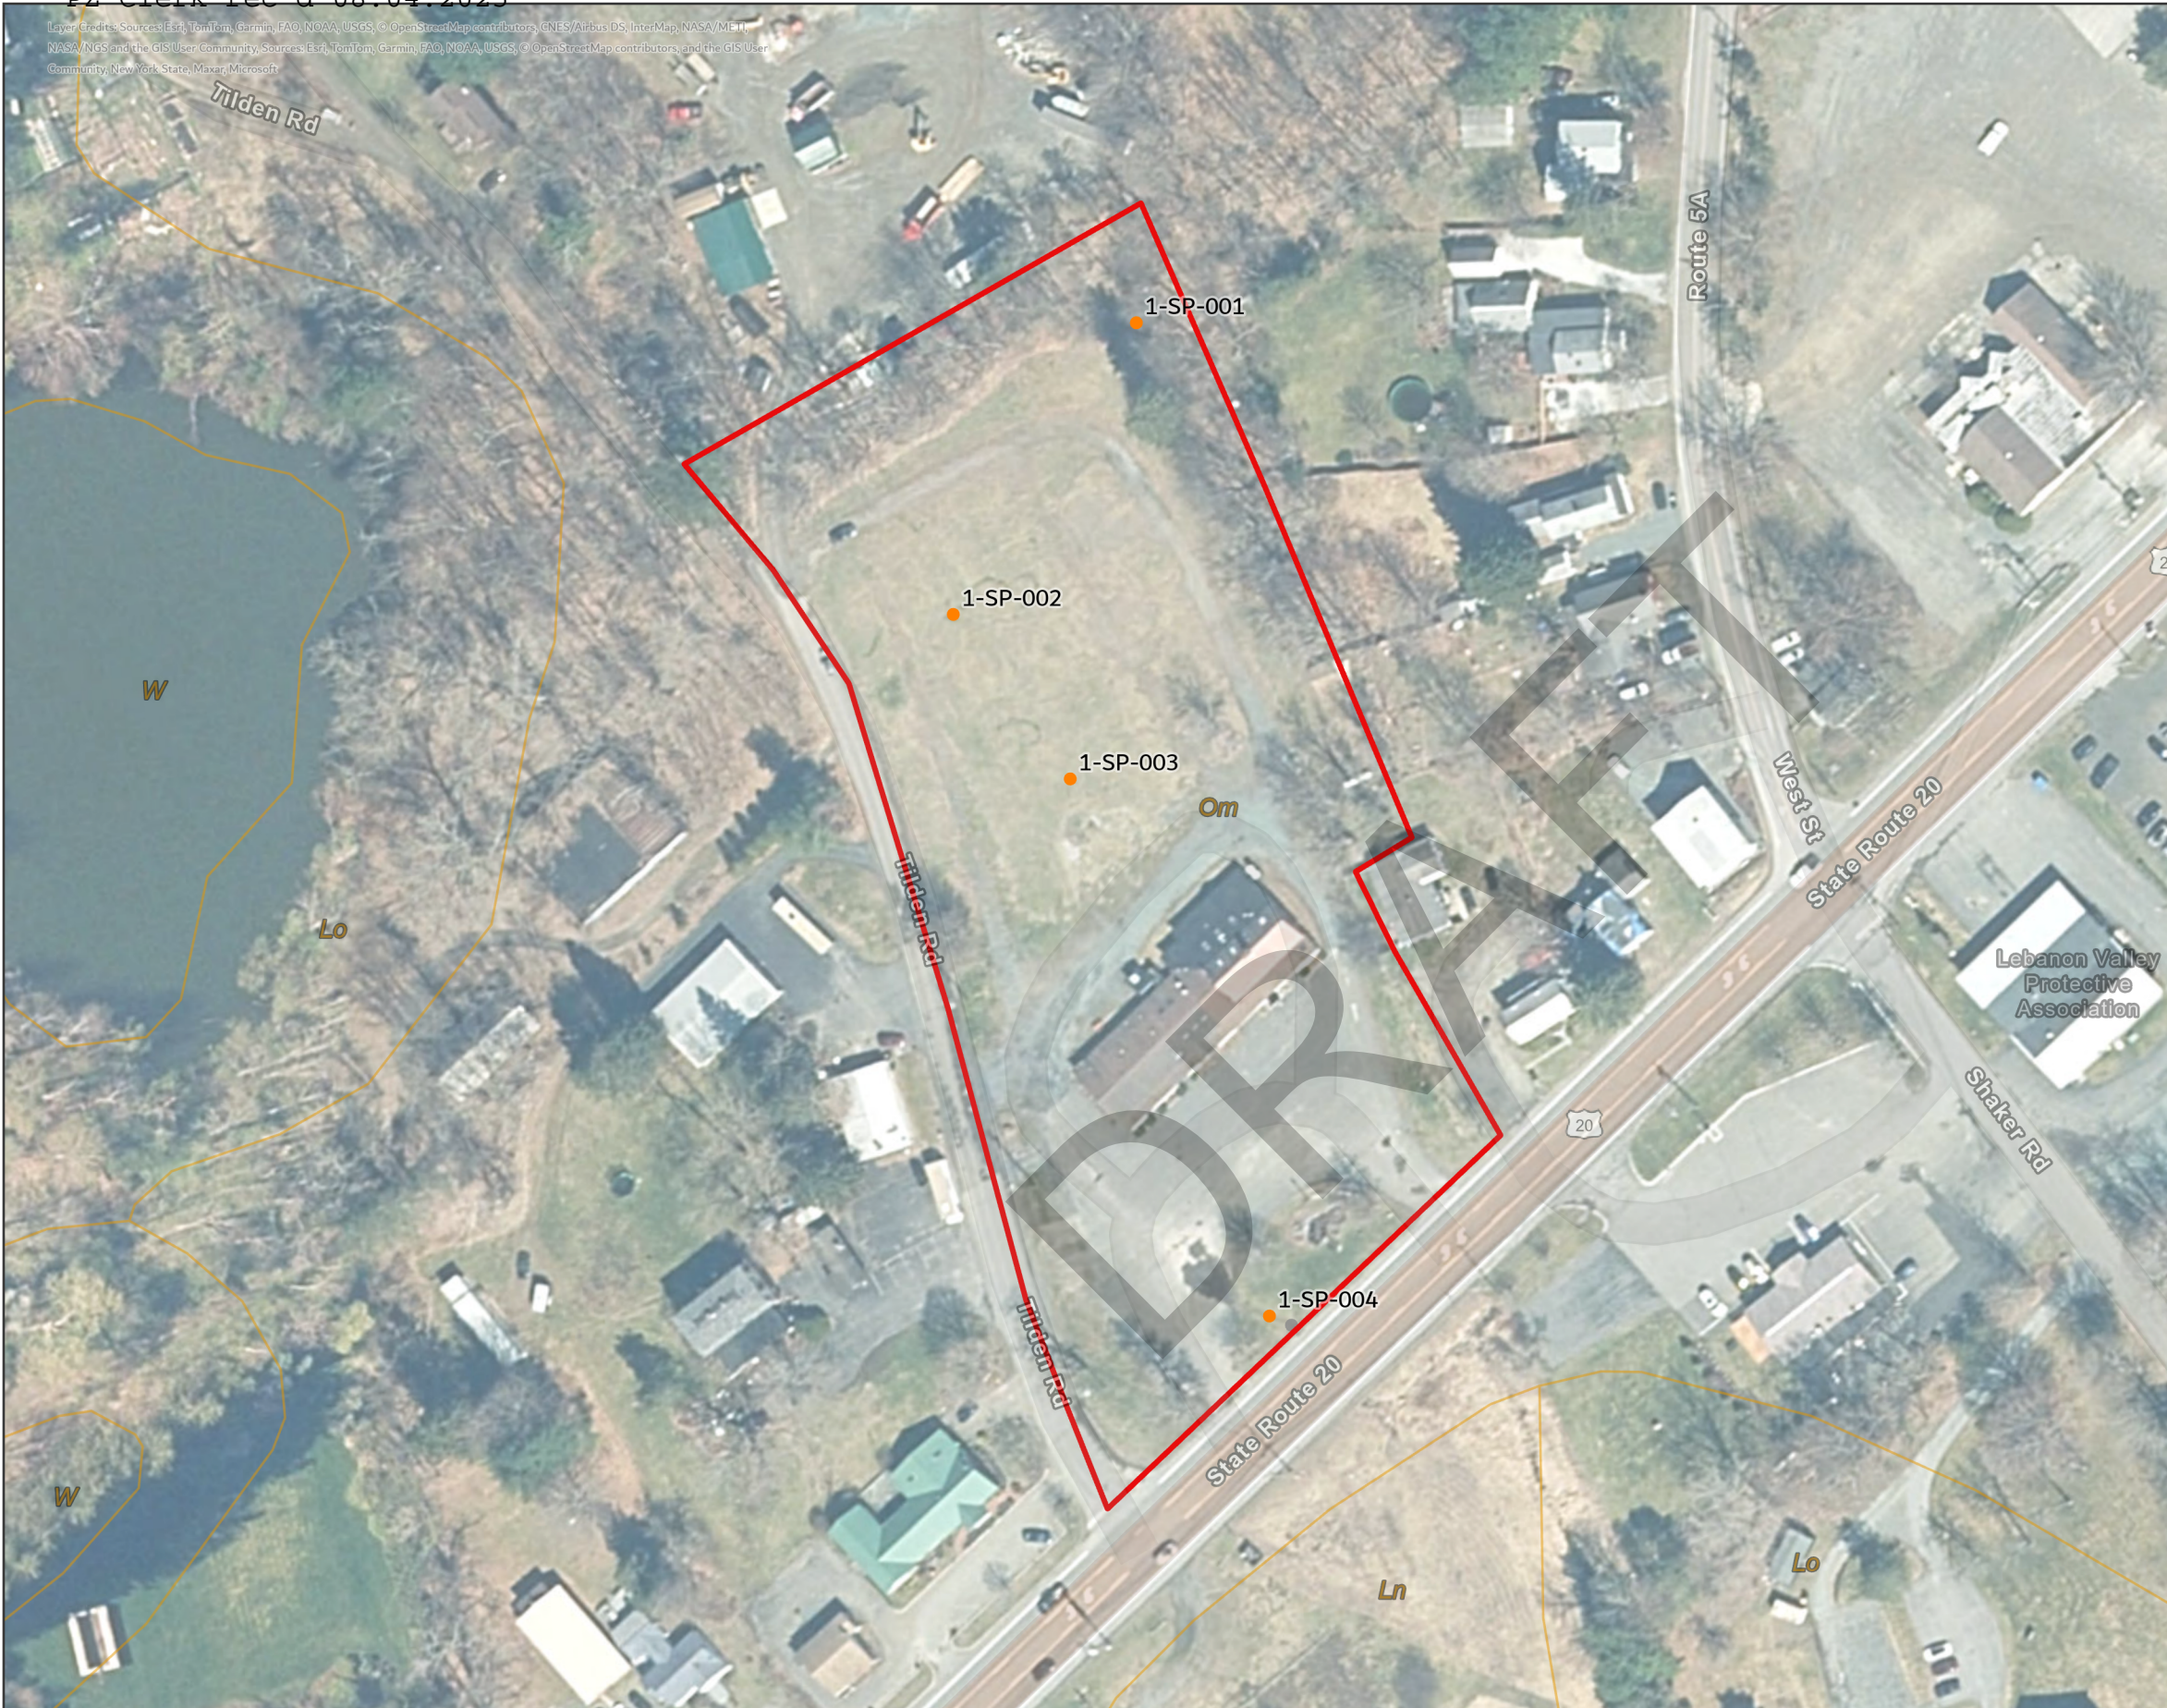
FIGURE 2

Field investigations confirmed current aerial imagery and identified no aquatic resources within the AOI. Additionally, four representative upland sample points were taken to characterize the area and identify soils and vegetation present on site. Representative photographs of the upland sample points are provided in Appendix C. The aquatic resource delineation map depicting upland sample point locations are provided as Appendix A, Figure 2. Field data sheets for sample points are provided in Appendix D.

AQUATIC RESOURCE DELINEATION MAP

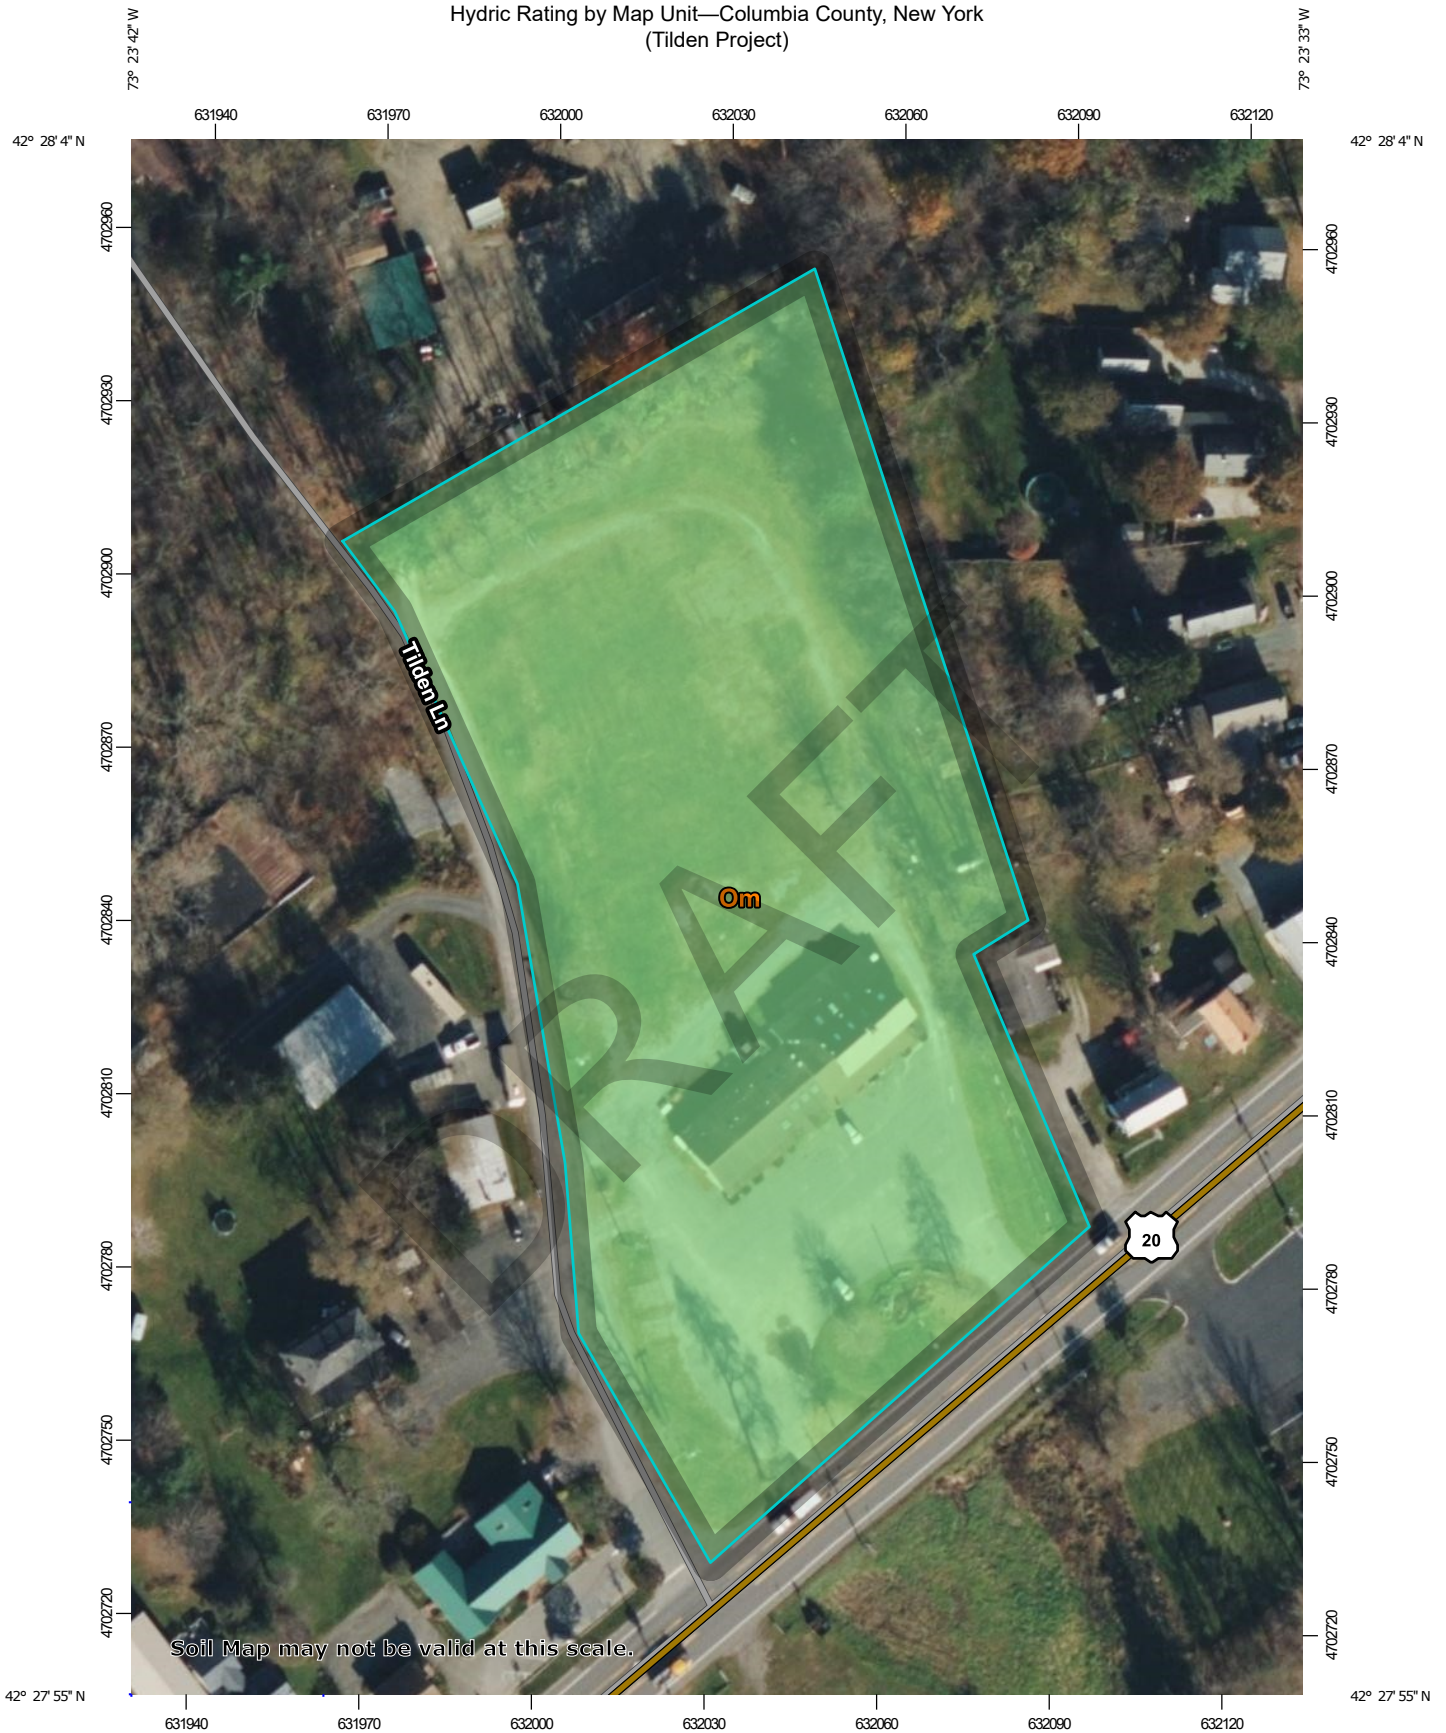
Hydric Rating by Map Unit—Columbia County, New York
(Tilden Project)

One hydric soil series was mapped by the Natural Resources Conservation Service (NRCS). The NRCS soil map and hydric soils list is provided in Appendix B.

Map unit symbol	Map unit name	Rating	Acres in AOI	Percent of AOI
Om	Occum loam	2	3.8	100.0%
Totals for Area of Interest			3.8	100.0%

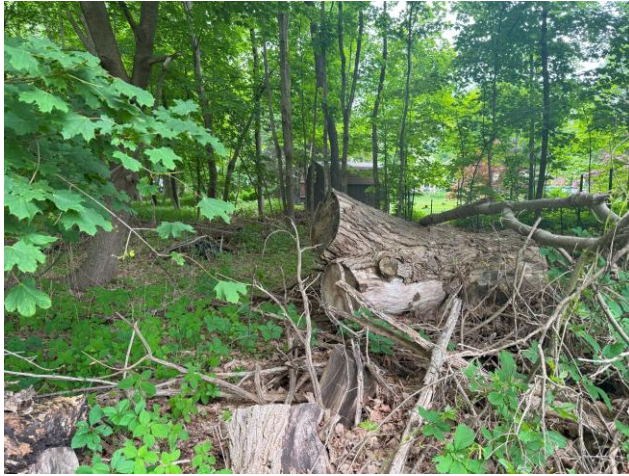
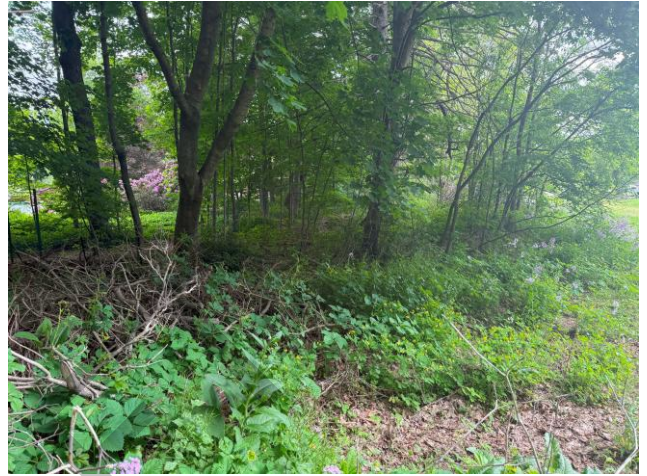
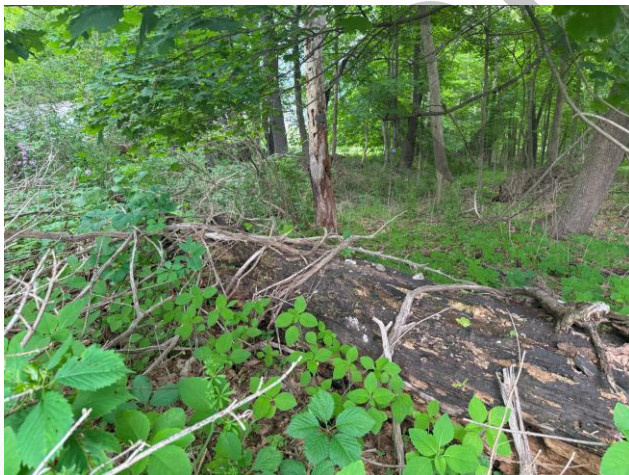
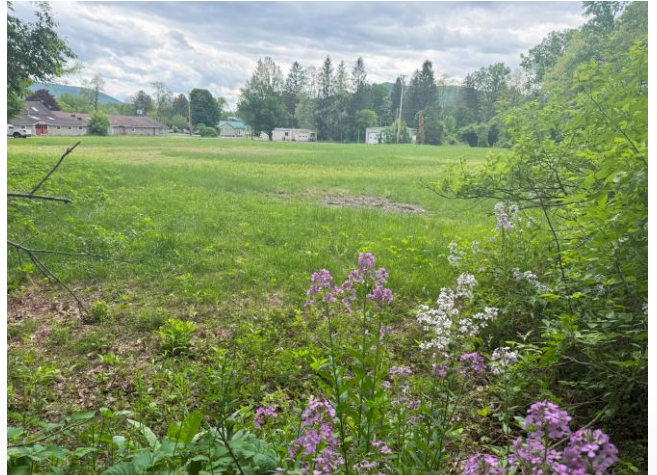
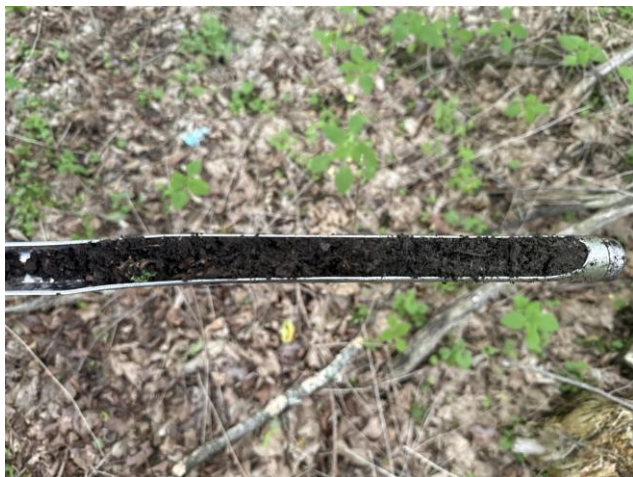
Upland 1-SP-001

Remarks: (Explain alternative procedures here or in a separate report.)
Upland sample located on woodlot/field edge.

Remarks:
No hydrology present

No hydrophytic vegetation present

No hydric soil present

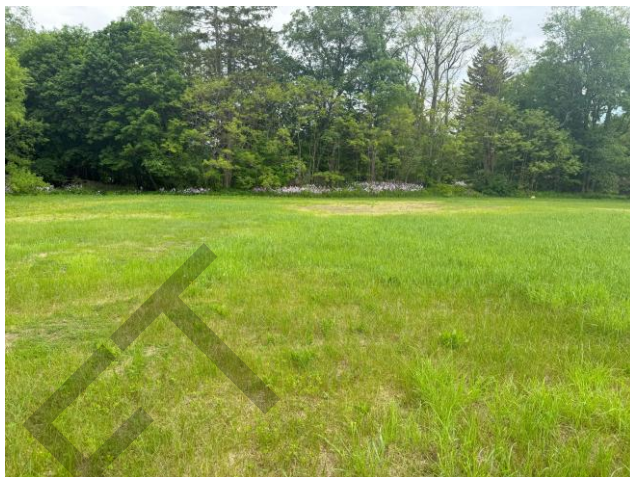
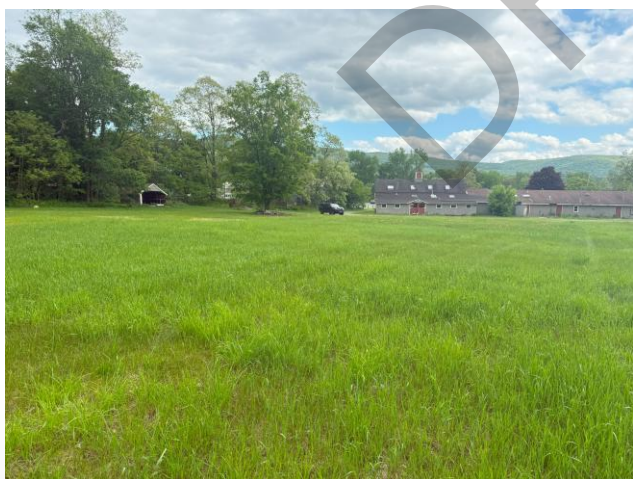
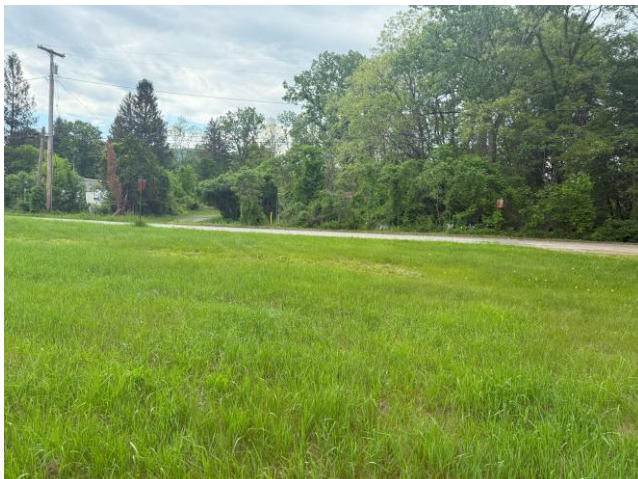
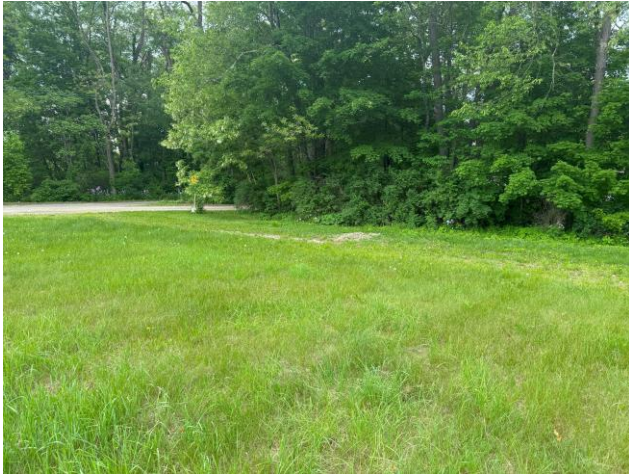
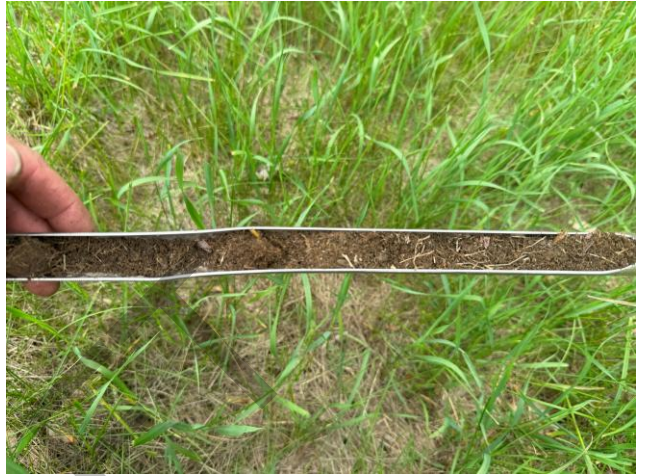
Upland 1-SP-002

Remarks: (Explain alternative procedures here or in a separate report.)
Upland sample located in mowed field/lawn.

Remarks:
No hydrology present
